FARMINGTON RIVER BASIN
HARWINTON, CONNECTICUT

BRISTOL RESERVOIR NO.5 DAM
CT 00366

PHASE I INSPECTION REPORT
NATIONAL DAM INSPECTION PROGRAM

JULY 1980

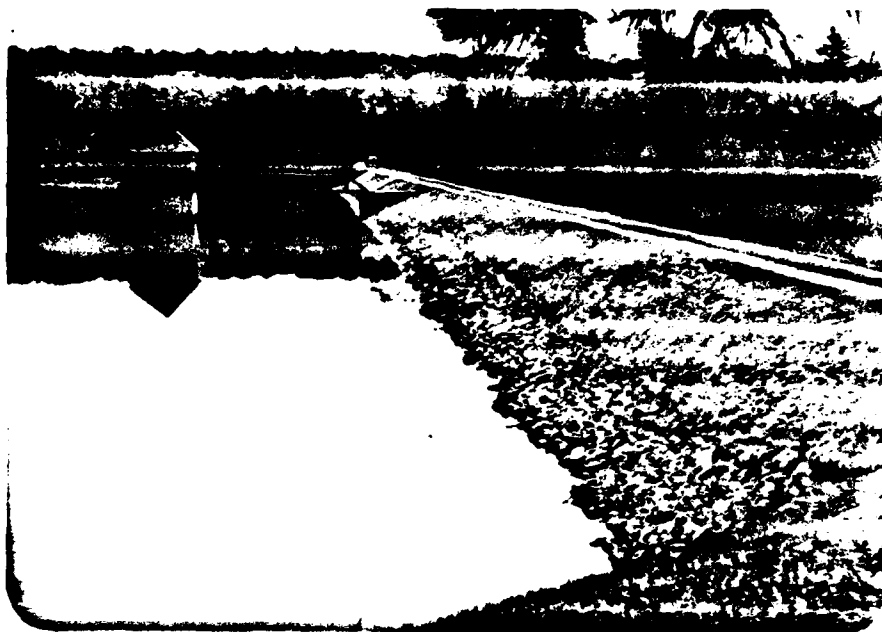
PHOTO NO. 1

MAIN DAM FROM RIGHT ABUTMENT

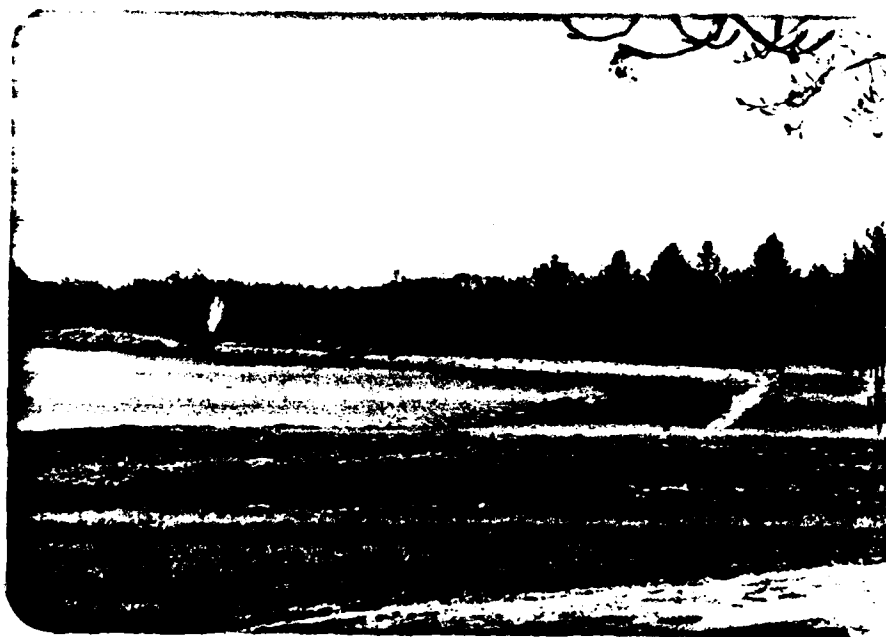
PHOTO NO. 2

OVERVIEW OF DIKE

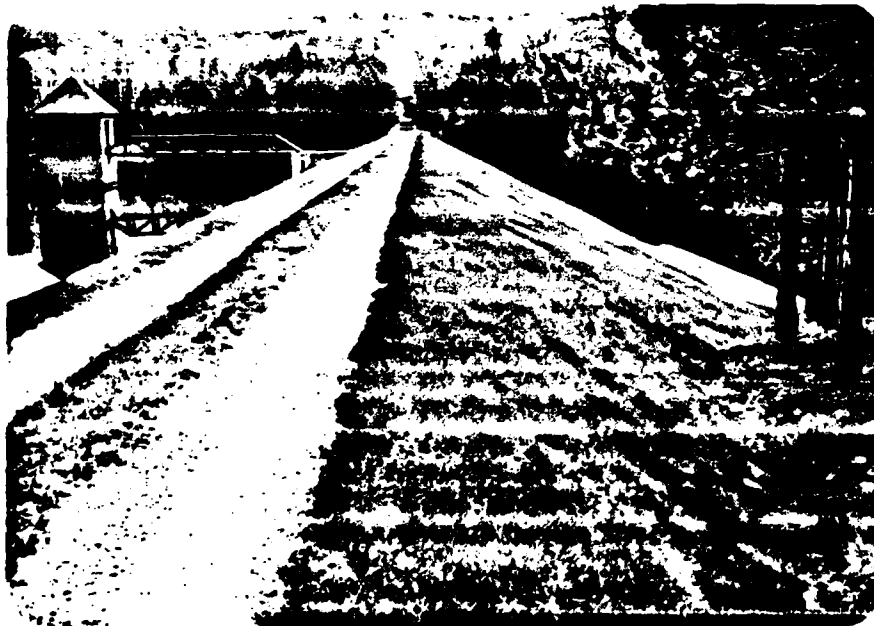
PHOTO NO. 4

CREST AND DOWNSTREAM SLOPE
OF DAM

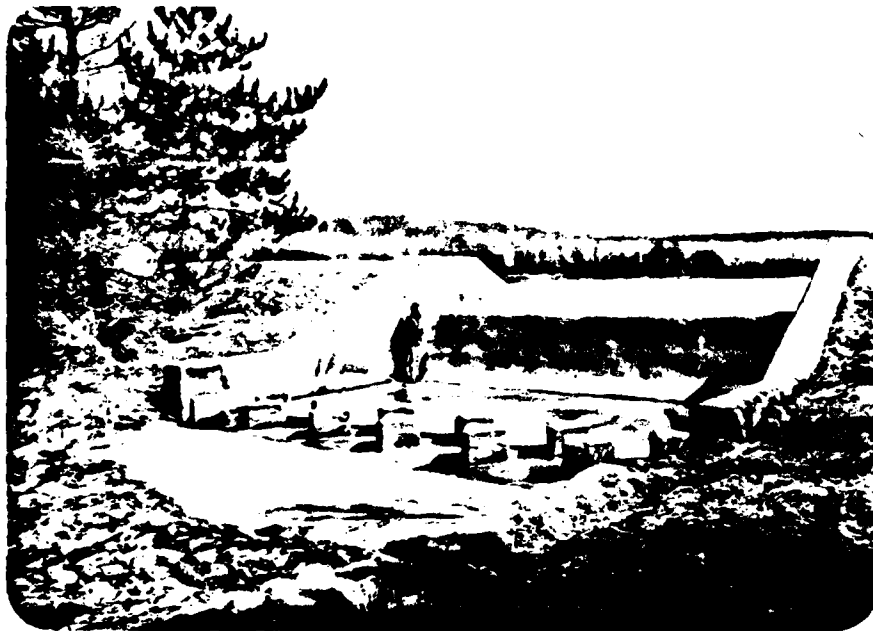
PHOTO NO. 10*

The concrete overflow spillway appeared to be in good condition. The surface was recently gunited. Some seepage through the overflow section was observed along a crack in the gunite near the right end of the spillway, Photo 10. The training walls are generally in good condition. There are concrete impact baffle blocks downstream of the spillway weir. A concrete apron beyond the baffle blocks appears to have been recently added. Undermining was observed at the upstream end of the apron near the right side of the spillway. Seepage was also observed near the downstream end of the apron.

SPILLWAY. NOTE SEEPAGE NEAR RIGHT END
AND CONCRETE APRON DOWNSTREAM OF IMPACT BAFFLE BLOCKS.

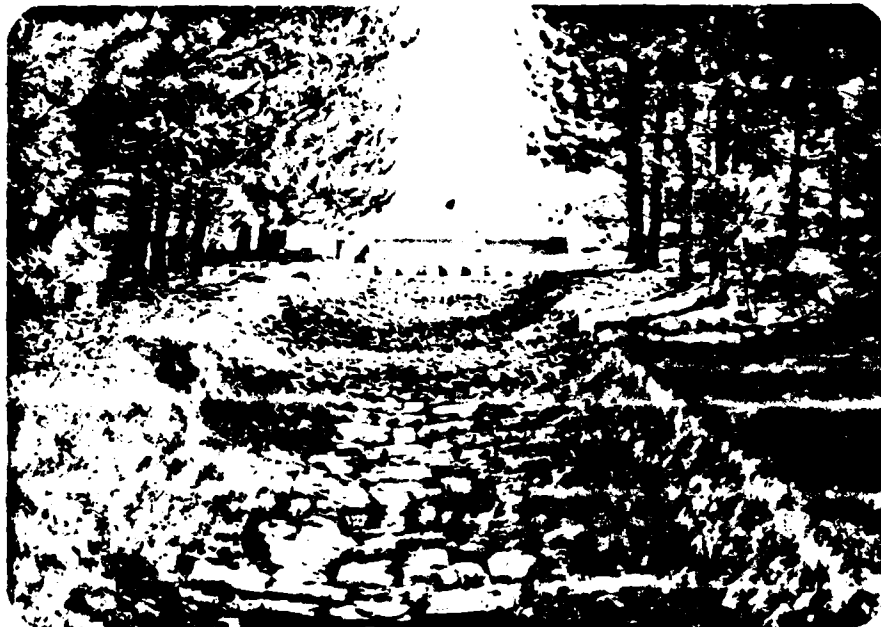
PHOTO NO. 11

The discharge channel is lined with hand-placed riprap. The left bank of the channel is inclined and faced with riprap. A section of the channel approximately 50 feet long washed out during a March 1980 storm. This section of the channel was repaired with crushed stone up to 8-inches in diameter, Photo 11.

4. Potential increase in the deterioration of the floor of the spillway discharge channel can lead to undermining of the spillway weir and adjoining training walls.

SPILLWAY DISCHARGE CHANNEL.
NOTE HAND PLACED RIPRAP PAVING IN FOREGROUND
AND CRUSHED STONE IN BACKGROUND.

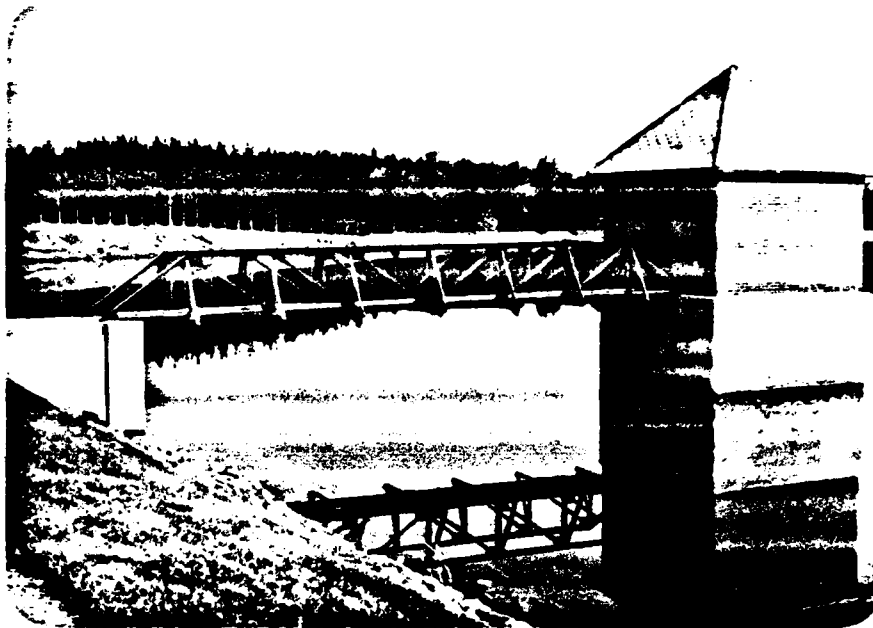
PHOTO NO. 12

The service bridge from the dam to the gatehouse consists of a steel truss with a wood deck. The bridge appeared to be in good condition, Photo 12.

GATEHOUSE AND SERVICE BRIDGE.
NOTE DETERIORATED CONCRETE NEAR WATER LINE.
